Large Scale Residential Development at Ratoath, Co. Meath

Stage 1 Road Safety Audit

Marshall Yards Development Company Ltd.

May 2024

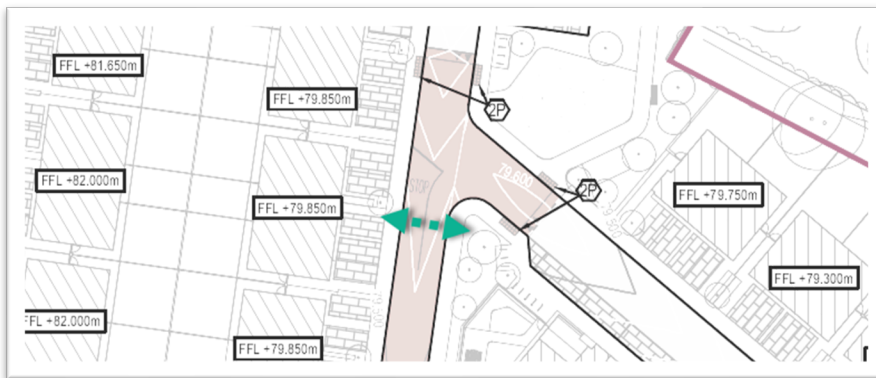
Figure 2.1 – Key Desire Line for People Walking to / from the Main Access

2.1 Problem: Facilitating Need for Pedestrians to Cross

Location: Internal Street T-Junction Near Main Access

Failing to cater for this key pedestrian desire line connecting the main access to the site could result in slips, trips and progression issues for mobility impaired road users.

Recommendation

An appropriate pedestrian crossing should be provided at the location described above.

3.1	Yes	Yes	A pedestrian crossing point has been added at the subject location. Please refer to the updated DOBA Drawing 2334-DOB-XX-SI-DR-C-0500-0502.	Comment noted with thanks.

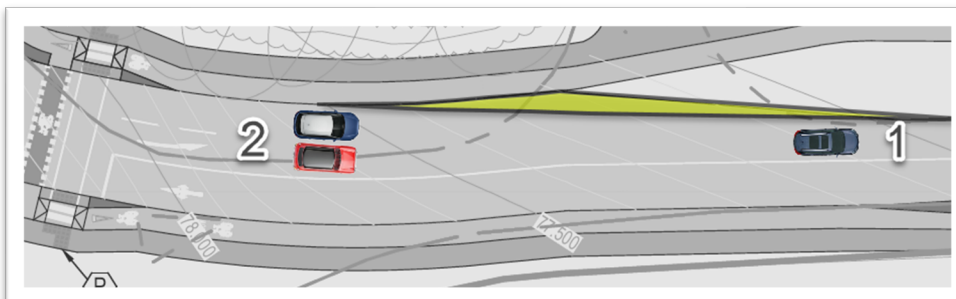
Figure 2.2 – Angular Directional Change in Nearside Kerb Line

2.2 Problem: Guidance for Drivers at Lane Drop / Merge Point

Location: Eastbound Exit from New Signal Controlled Junction

Drivers in Lane 1 approaching the merge from dual to single lanes will take guidance from the nearside kerb line, which appears faceted (or changes direction in a sharp angular manner). This could increase the risk of side swipe type collisions here, particularly in free-flow conditions.

Recommendation

The alignment of the nearside kerb line should be adjusted to provide a smooth and predictable transition from dual lanes to a single lane.

3.2	Yes	Yes	The alignment of the road has been changed at a location immediately east of the proposed new junction and the pinch point has been removed. Please refer to the updated DOBA Drawing 2334-DOB-XX-SI-DR-C-0500-0502.	Comment noted with thanks.

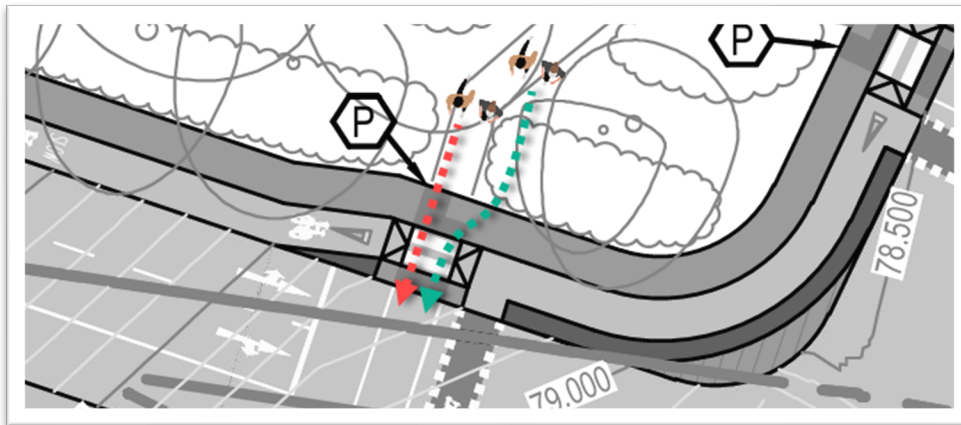
Figure 2.3 – Pedestrian Approaching the Crossing from Internal Footpath (Red Arrow)

2.3 Problem: Conflicts for Pedestrians Joining the Public Footpath

Location: Internal Footpath Connection to South-East Corner of Main Site

Pedestrians approaching a green pedestrian crossing light may cross the footpath and cycle track without checking for approaching walkers and cyclists. This could increase the risk of conflict between pedestrians and cyclist at this location.

Recommendation

The internal footpath connection point should be offset to the right (see green arrow above), to encourage pedestrians to look towards the footpath and cycle track they are about to cross.

3.3	Yes	Yes	The alignment of the footpath has been changed to be off-center from the crossing point at this junction. Please refer to the updated DOBA Drawing 2334-DOB-XX-SI-DR-C-0500-0502.	Comment noted with thanks.

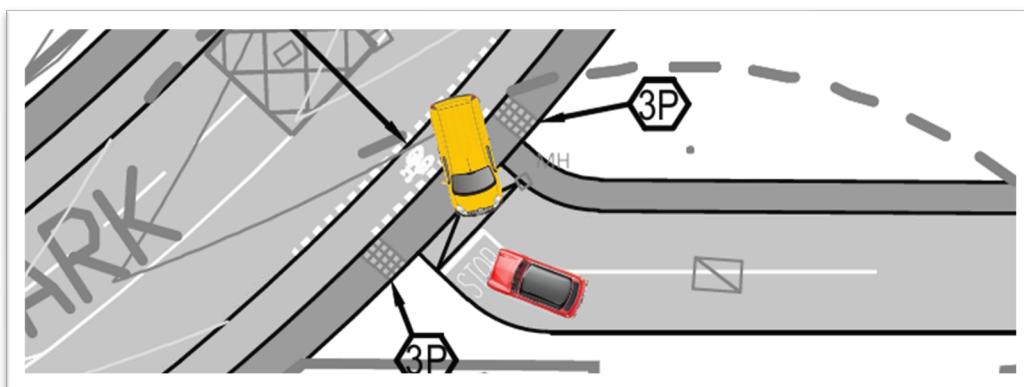
Figure 2.4 – Possible Opposition Conflict Scenario at Access Connection Point to Public Road

2.4 Problem: Access Approach Geometry & Opposition Conflicts

Location: Private Access - Southbound Exit from New Signal Controlled Junction

The low radius horizontal curve immediately in advance of the stop line could lead to Stop line 'overshoots' and opposition type conflicts between vehicles entering and exiting the access simultaneously.

Recommendation

The radius of the horizontal curve immediately in advance of the stop line should be increased to mitigate the risk described.

3.4	Yes	Yes	The kerb radii immediately east of the Stop Sign have been increased to flatten out the approach angle and mitigate any possible conflicts. Please refer to the updated DOBA Drawing 2334-DOB-XX-SI-DR-C-0500-0502.	Comment noted with thanks.
